Canopy Walk

By Spence Rosenfeld, RCA #332
President, Arbogaurd Tree Specialists

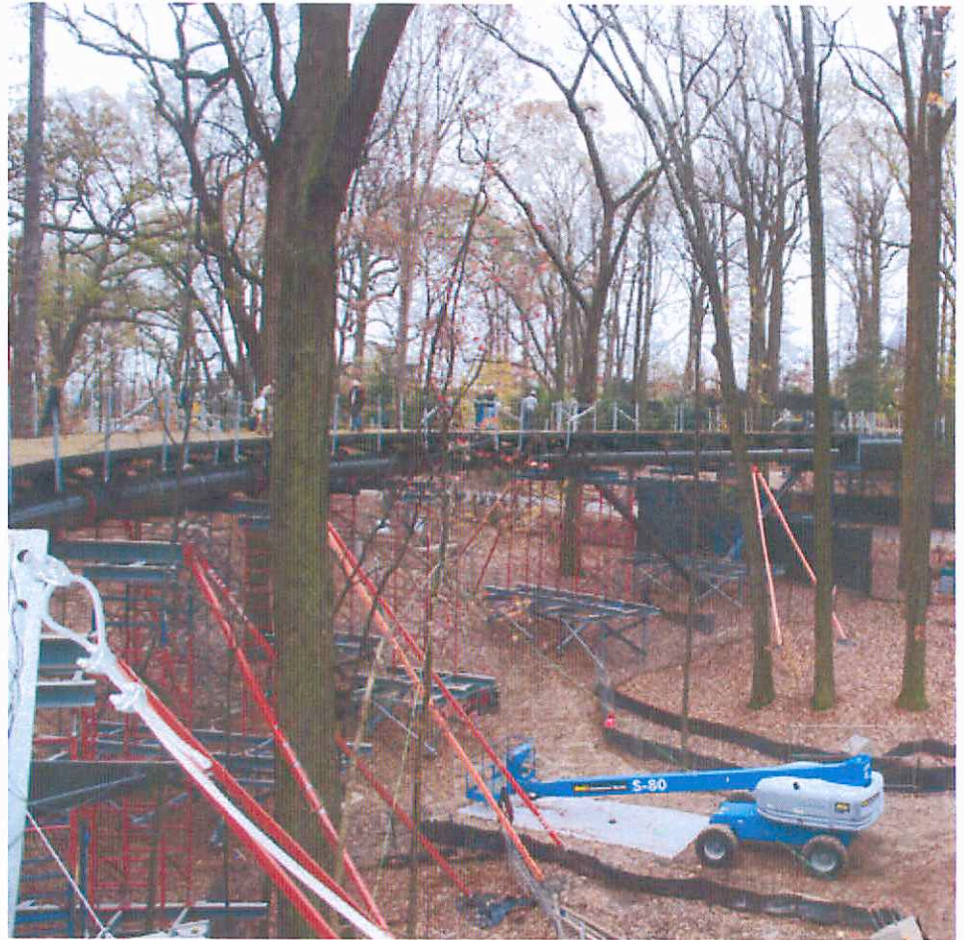
Piers and Helical Anchors (far shot): Providing ground support for temporary walkway scaffolding.

a scaffold system made up of 16 scaffold towers was necessary. Originally, these were to be built on graded slabs to provide a flat base, which required extensive grading. Instead, they were installed using helical anchors to straddle roots, reducing the impact by over 98% in these areas. To further reduce root loss during the installation of the helical anchors, an Air-Spade® was utilized to blow soil off areas where anchors were needed. Once tree roots were exposed, it was then possible to hand thread anchors through the root system.

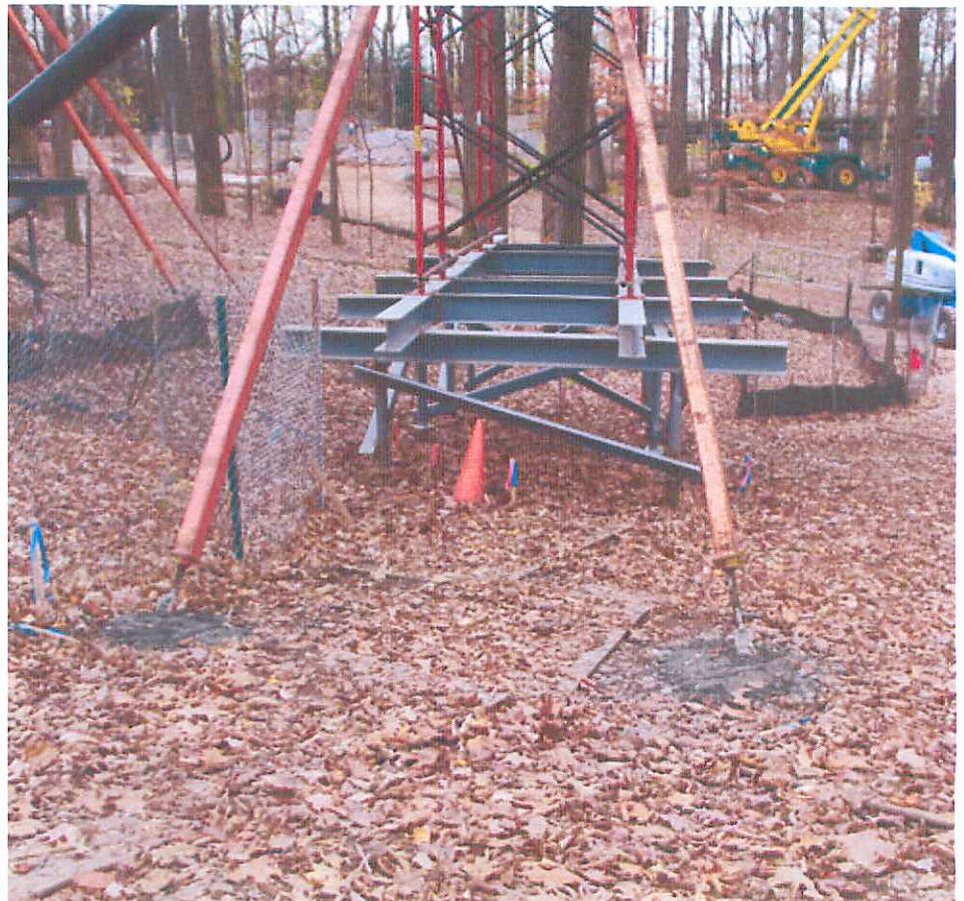
Piers and Helical Anchors (close shot): Providing ground support for temporary walkway scaffolding.

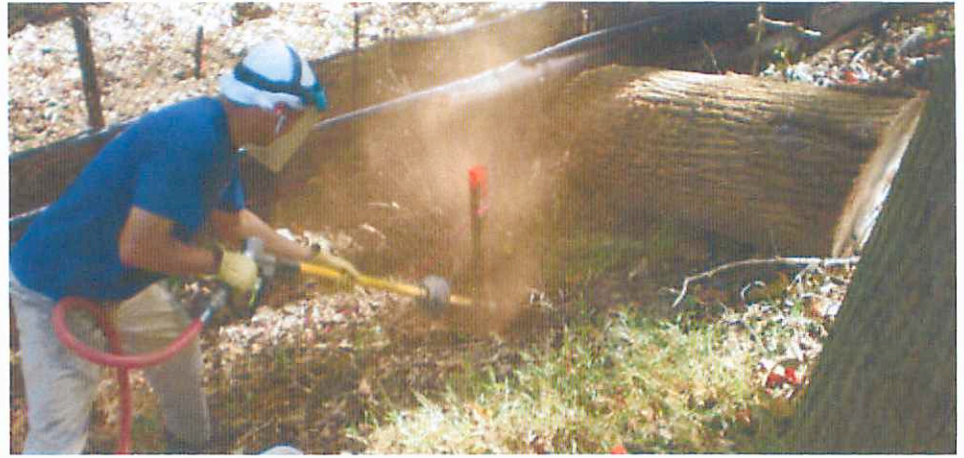
Air-Spade® for helical anchor 1: Blowing soil off root system prior to helical anchor insertion.

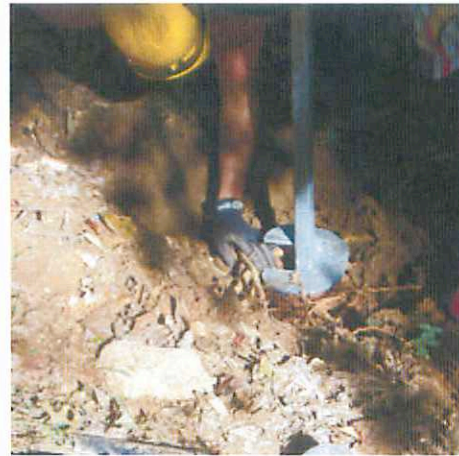
Left: Air-Spade® for helical anchor 2: Threading helical anchor through exposed roots.

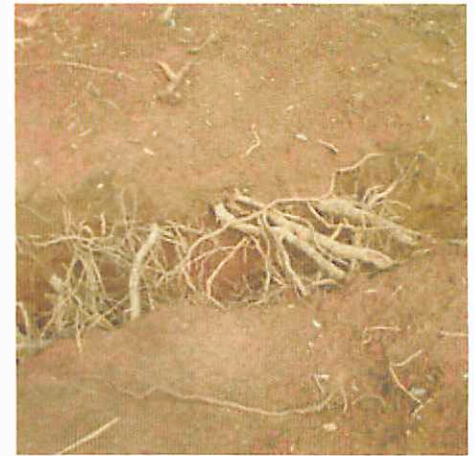
Right: Air-Spade® for utility lines: Blowing soil off root system to thread utility lines underneath.

- Instead of traditional utility line installation, where a backhoe would be used to trench through roots, an Air-Spade® was used to excavate around and below dense root mats so utility lines could be threaded below the roots. Air-Spade® excavation was used for the main electric line and substation connections, as well as most irrigation main lines.
- Subsurface drain lines were replaced with dry, hand-laid creek beds and surface flumes that became attractive visual features, adding to the interest and beauty of the gardens. In one case, a 14' deep by 12" wide drain line, which would have cost over \$100K, was eliminated and replaced with a much less expensive surface flume, while preserving 7 massive native Poplars.

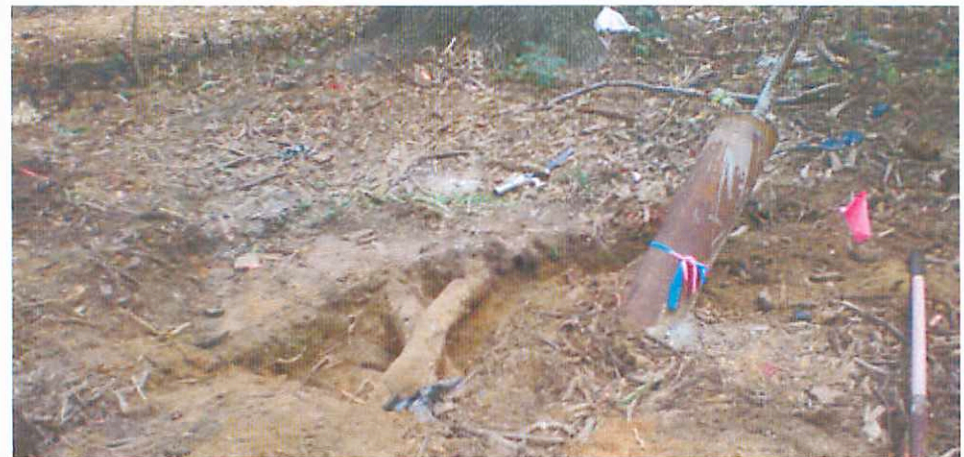
Micropiles (before): Eliminating 12'x12' underground concrete slab.

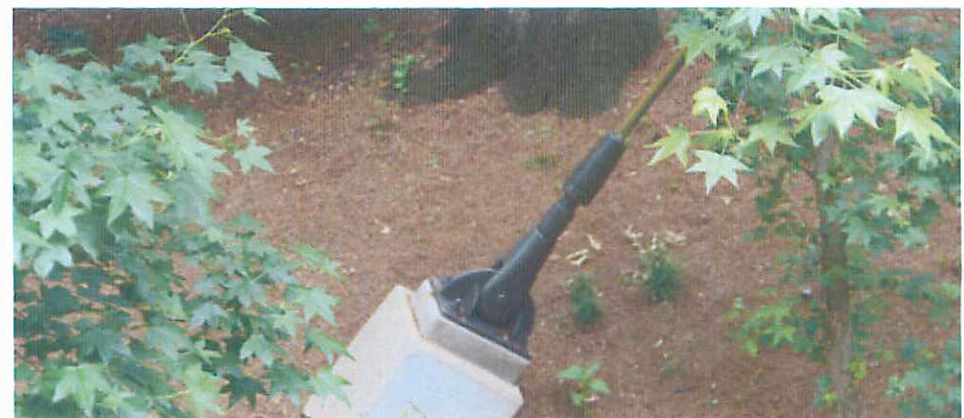
Micropiles (after): Completed micropile anchor.

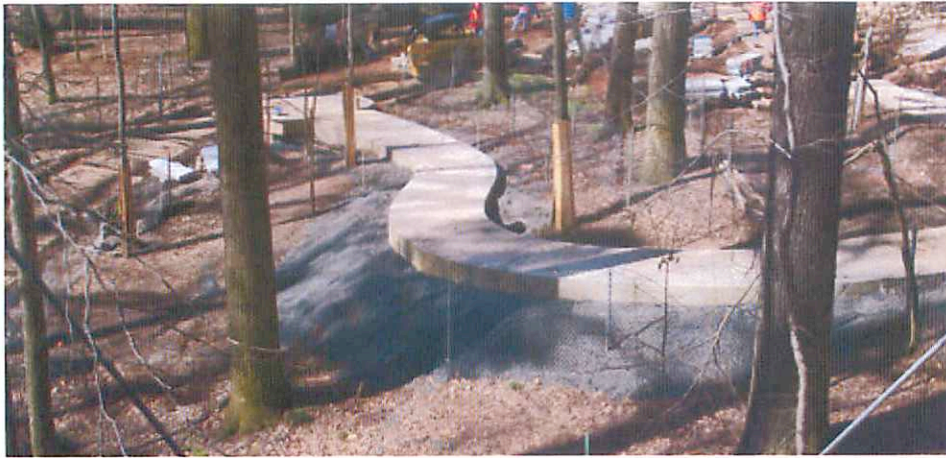
Root Bridging (before): Constructing walkways above-ground.

- Numerous retaining walls were designed to support surface sidewalks, allowing access deep into the woods. To replace traditional wall installation requiring extensive footings and root damage, all walkway construction was done above grade. This process, known as “root bridging,” involved laying geotextile fabric on grade and adding layers of expanded slate aggregate on top, forming a solid sub-base on top of which sidewalks were built. In some cases the sidewalks were “stapled” to the ground using long helical anchors to stabilize them, as an alternative to retaining walls with footings.
- A comprehensive Soil Therapy and Tree Health Care Program was implemented utilizing a battery of organic soil amendments and root stimulants to improve tree vitality and stimulate root regeneration.

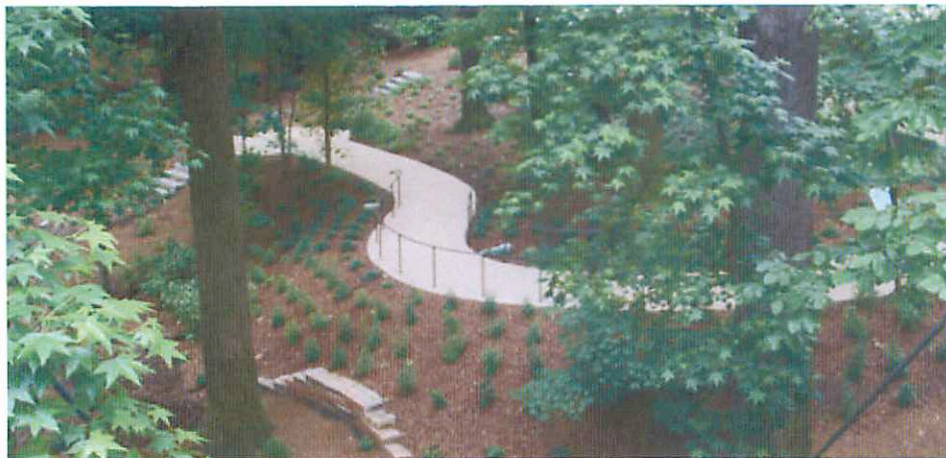
Root Bridging (after): Completed above-ground walkway.
